CSC Charlotte South

EPA R4 NPDES Inspection

Inspected on 5/29/19

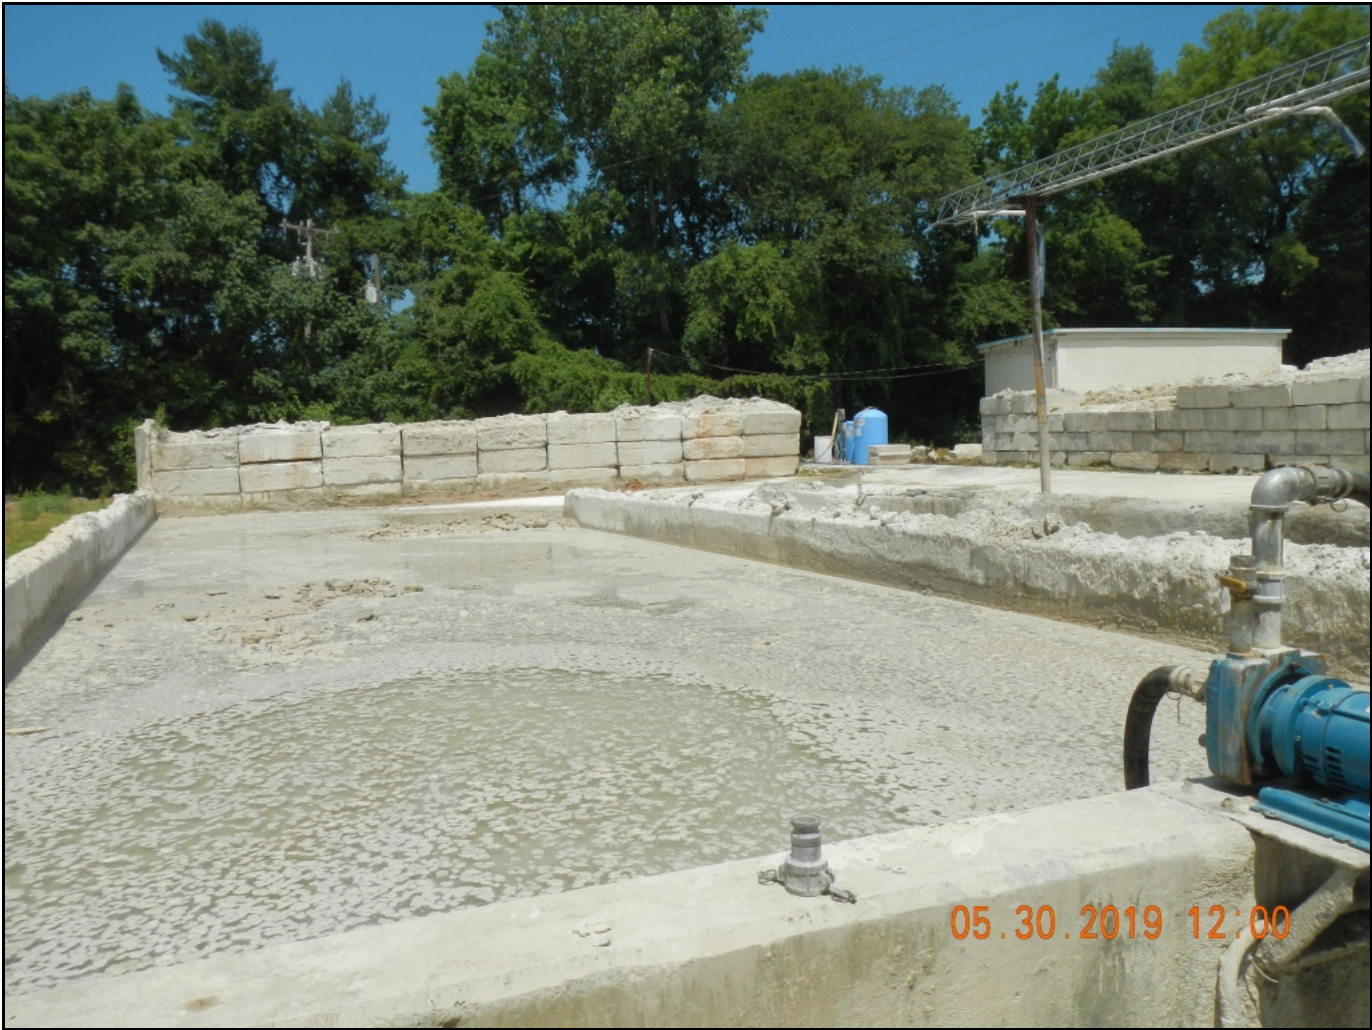
Attributes	
Description	Truck washout capture. Decanted water is reused

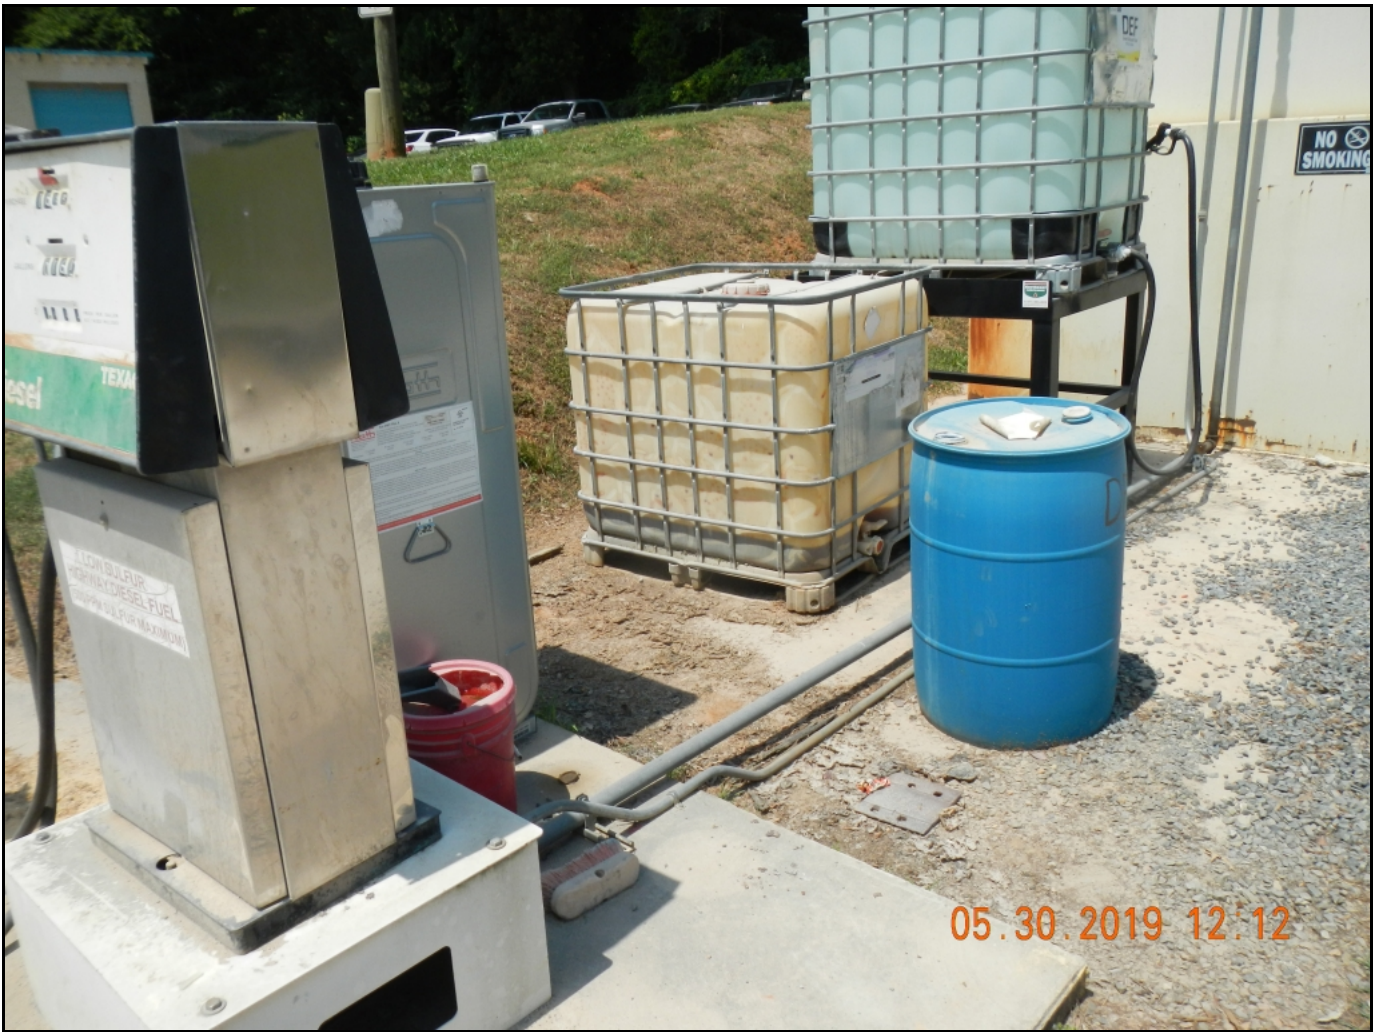
Attributes	
Description	Truck fuel stand. Spill kits (red bucket, 1 of 2 shown) had cracked lids and were filled with rainwater. Suggested that spill kits be replaced.

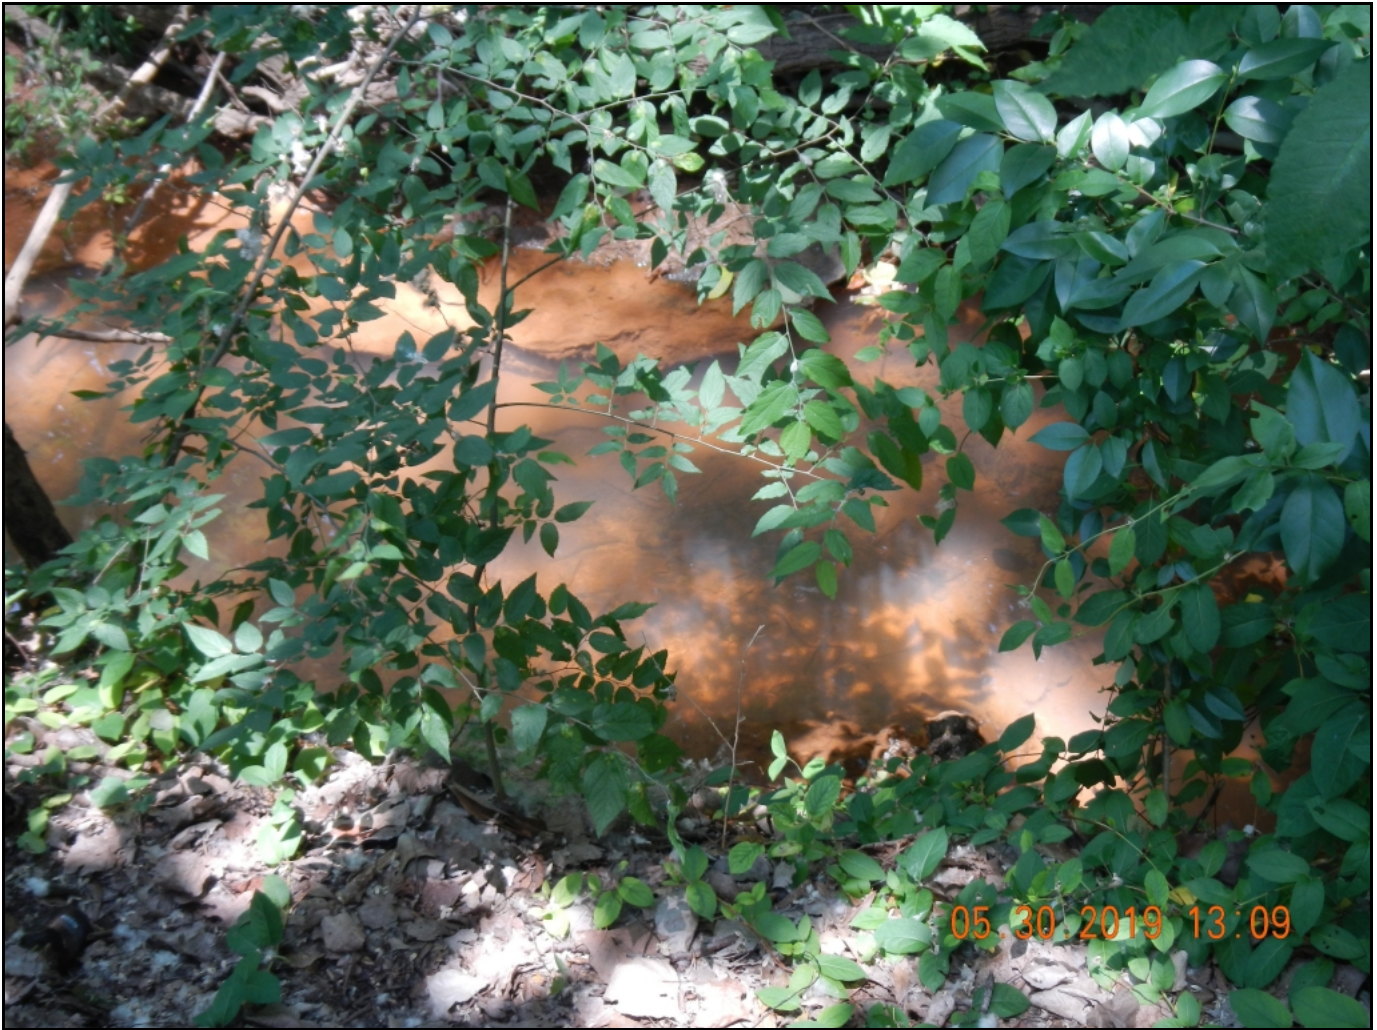
Description	After exiting the facility, inspectors looked at receiving water/ditch downstream of facility, where county had conducted sampling during the prior 12 months.
-------------	--
